**GREAT EAST LAKE  
DAM-BREACH FLOOD ANALYSIS  
WAKEFIELD, NEW HAMPSHIRE &  
NEWFIELD, MAINE**

GREAT EAST LAKE  
DAM-BREACH  
FLOOD ANALYSIS

Wakefield, New Hampshire  
and  
Newfield, Maine

Water Management Section  
Geotechnical and Water Management Branch  
Engineering/Planning Division

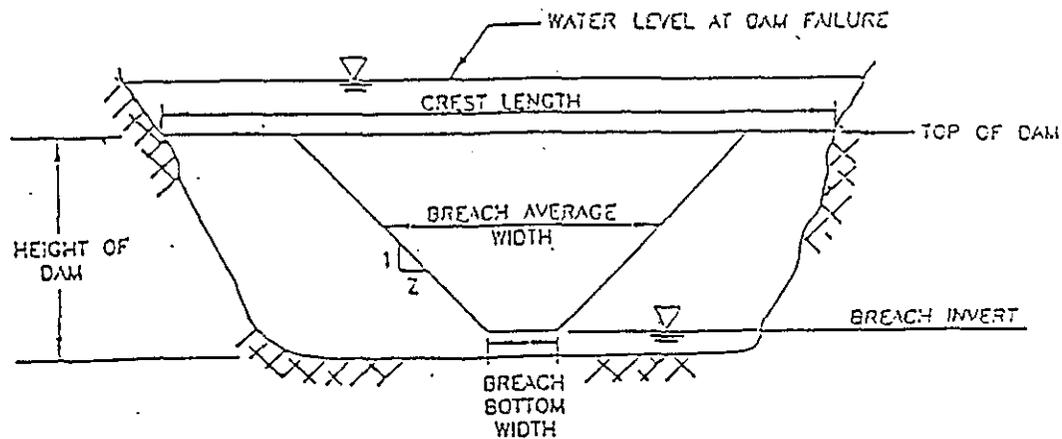
DEFINITION SKETCH OF BREACH PARAMETERS

b. Assumed Breach Parameters. The discharge hydrograph of a breach is a function of the inflow hydrograph and breach parameters (time of breach formation, size, and shape of breach) of a hypothetical dam failure. The following sketch illustrates the various dam breach parameters for a typical earthen or concrete-gravity dam. Total outflow is a combination of flows through the breach and spillway. As the breach develops, so does the breach discharge.

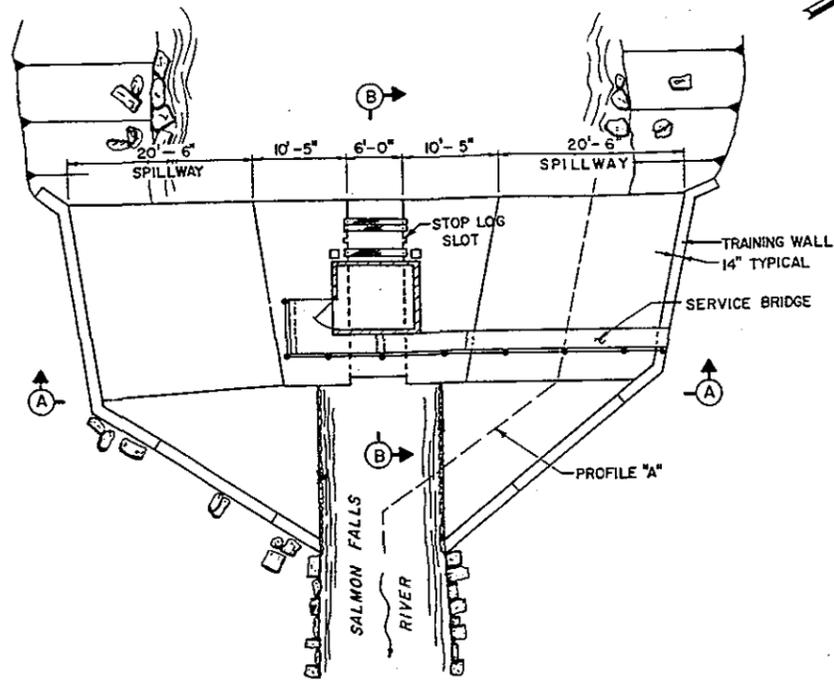
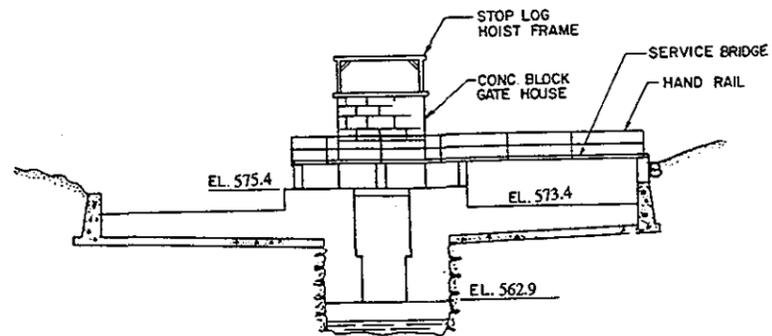
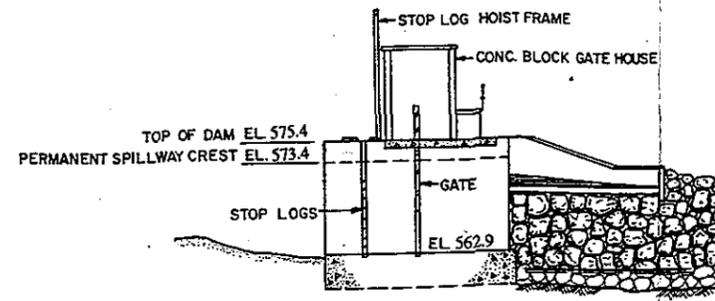
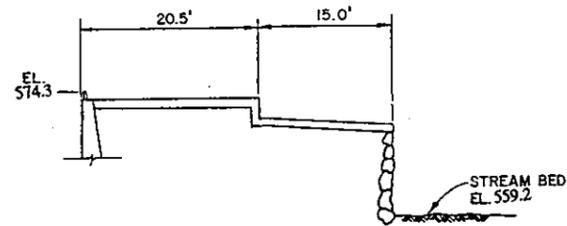
# GREAT EAST LAKE

PLAN

SECTION A-A

SECTION B-B

PROFILE "A"  
(FOR LOCATION, SEE PLAN)

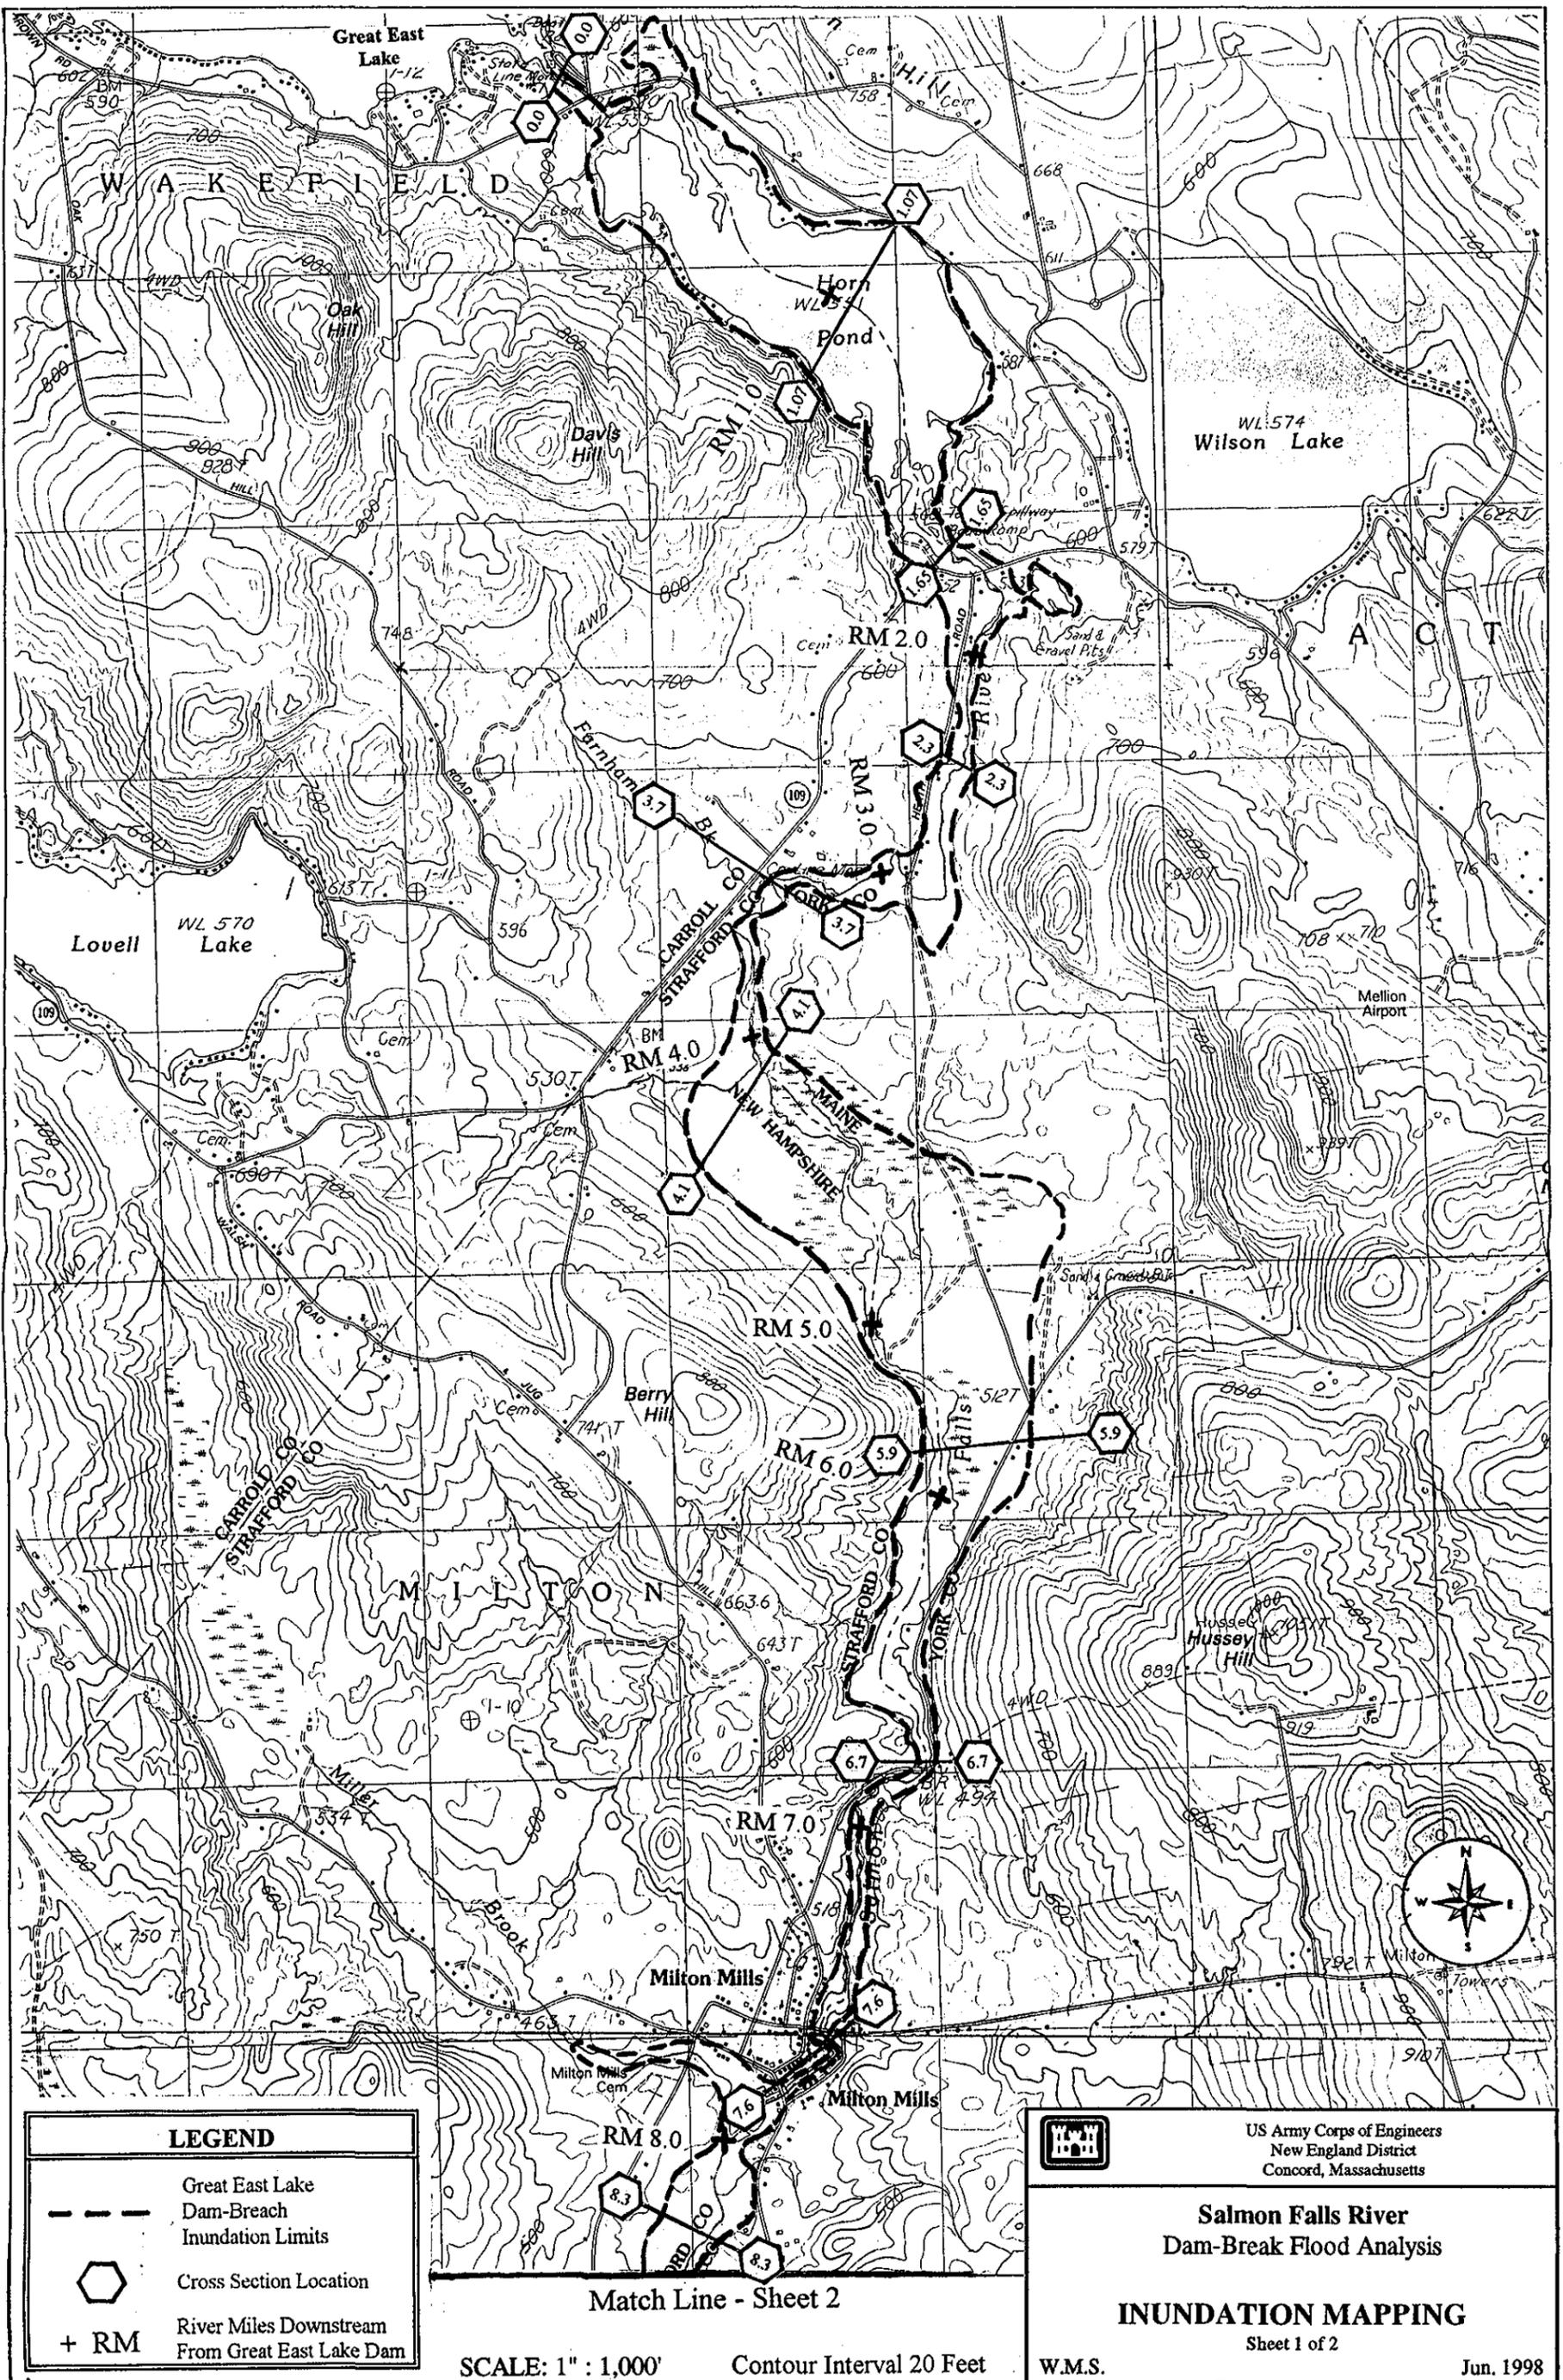
PLATE 3

LEGEND	
	Great East Lake Dam-Breach Inundation Limits
	Cross Section Location
	River Miles Downstream From Great East Lake Dam

The limits of inundation were computed by routing the breach discharge hydrograph through the downstream valley cross sections and delineating the resulting maximum stages on the base map. The base map used is based on a 20-foot contour interval 1:24,000 scale USGS quadrangle and, therefore, inundation limits shown on Plates 3 and 4 are only approximate. Inundation mapping with a larger scale of 1":1,000' is provided in Appendix I. Locations of the twenty selected downstream stations are graphically illustrated on Plates 3 and 4. Although any structures shown within these limits were assumed to be inundated, certain structures may be excluded as a result of local conditions and elevations.

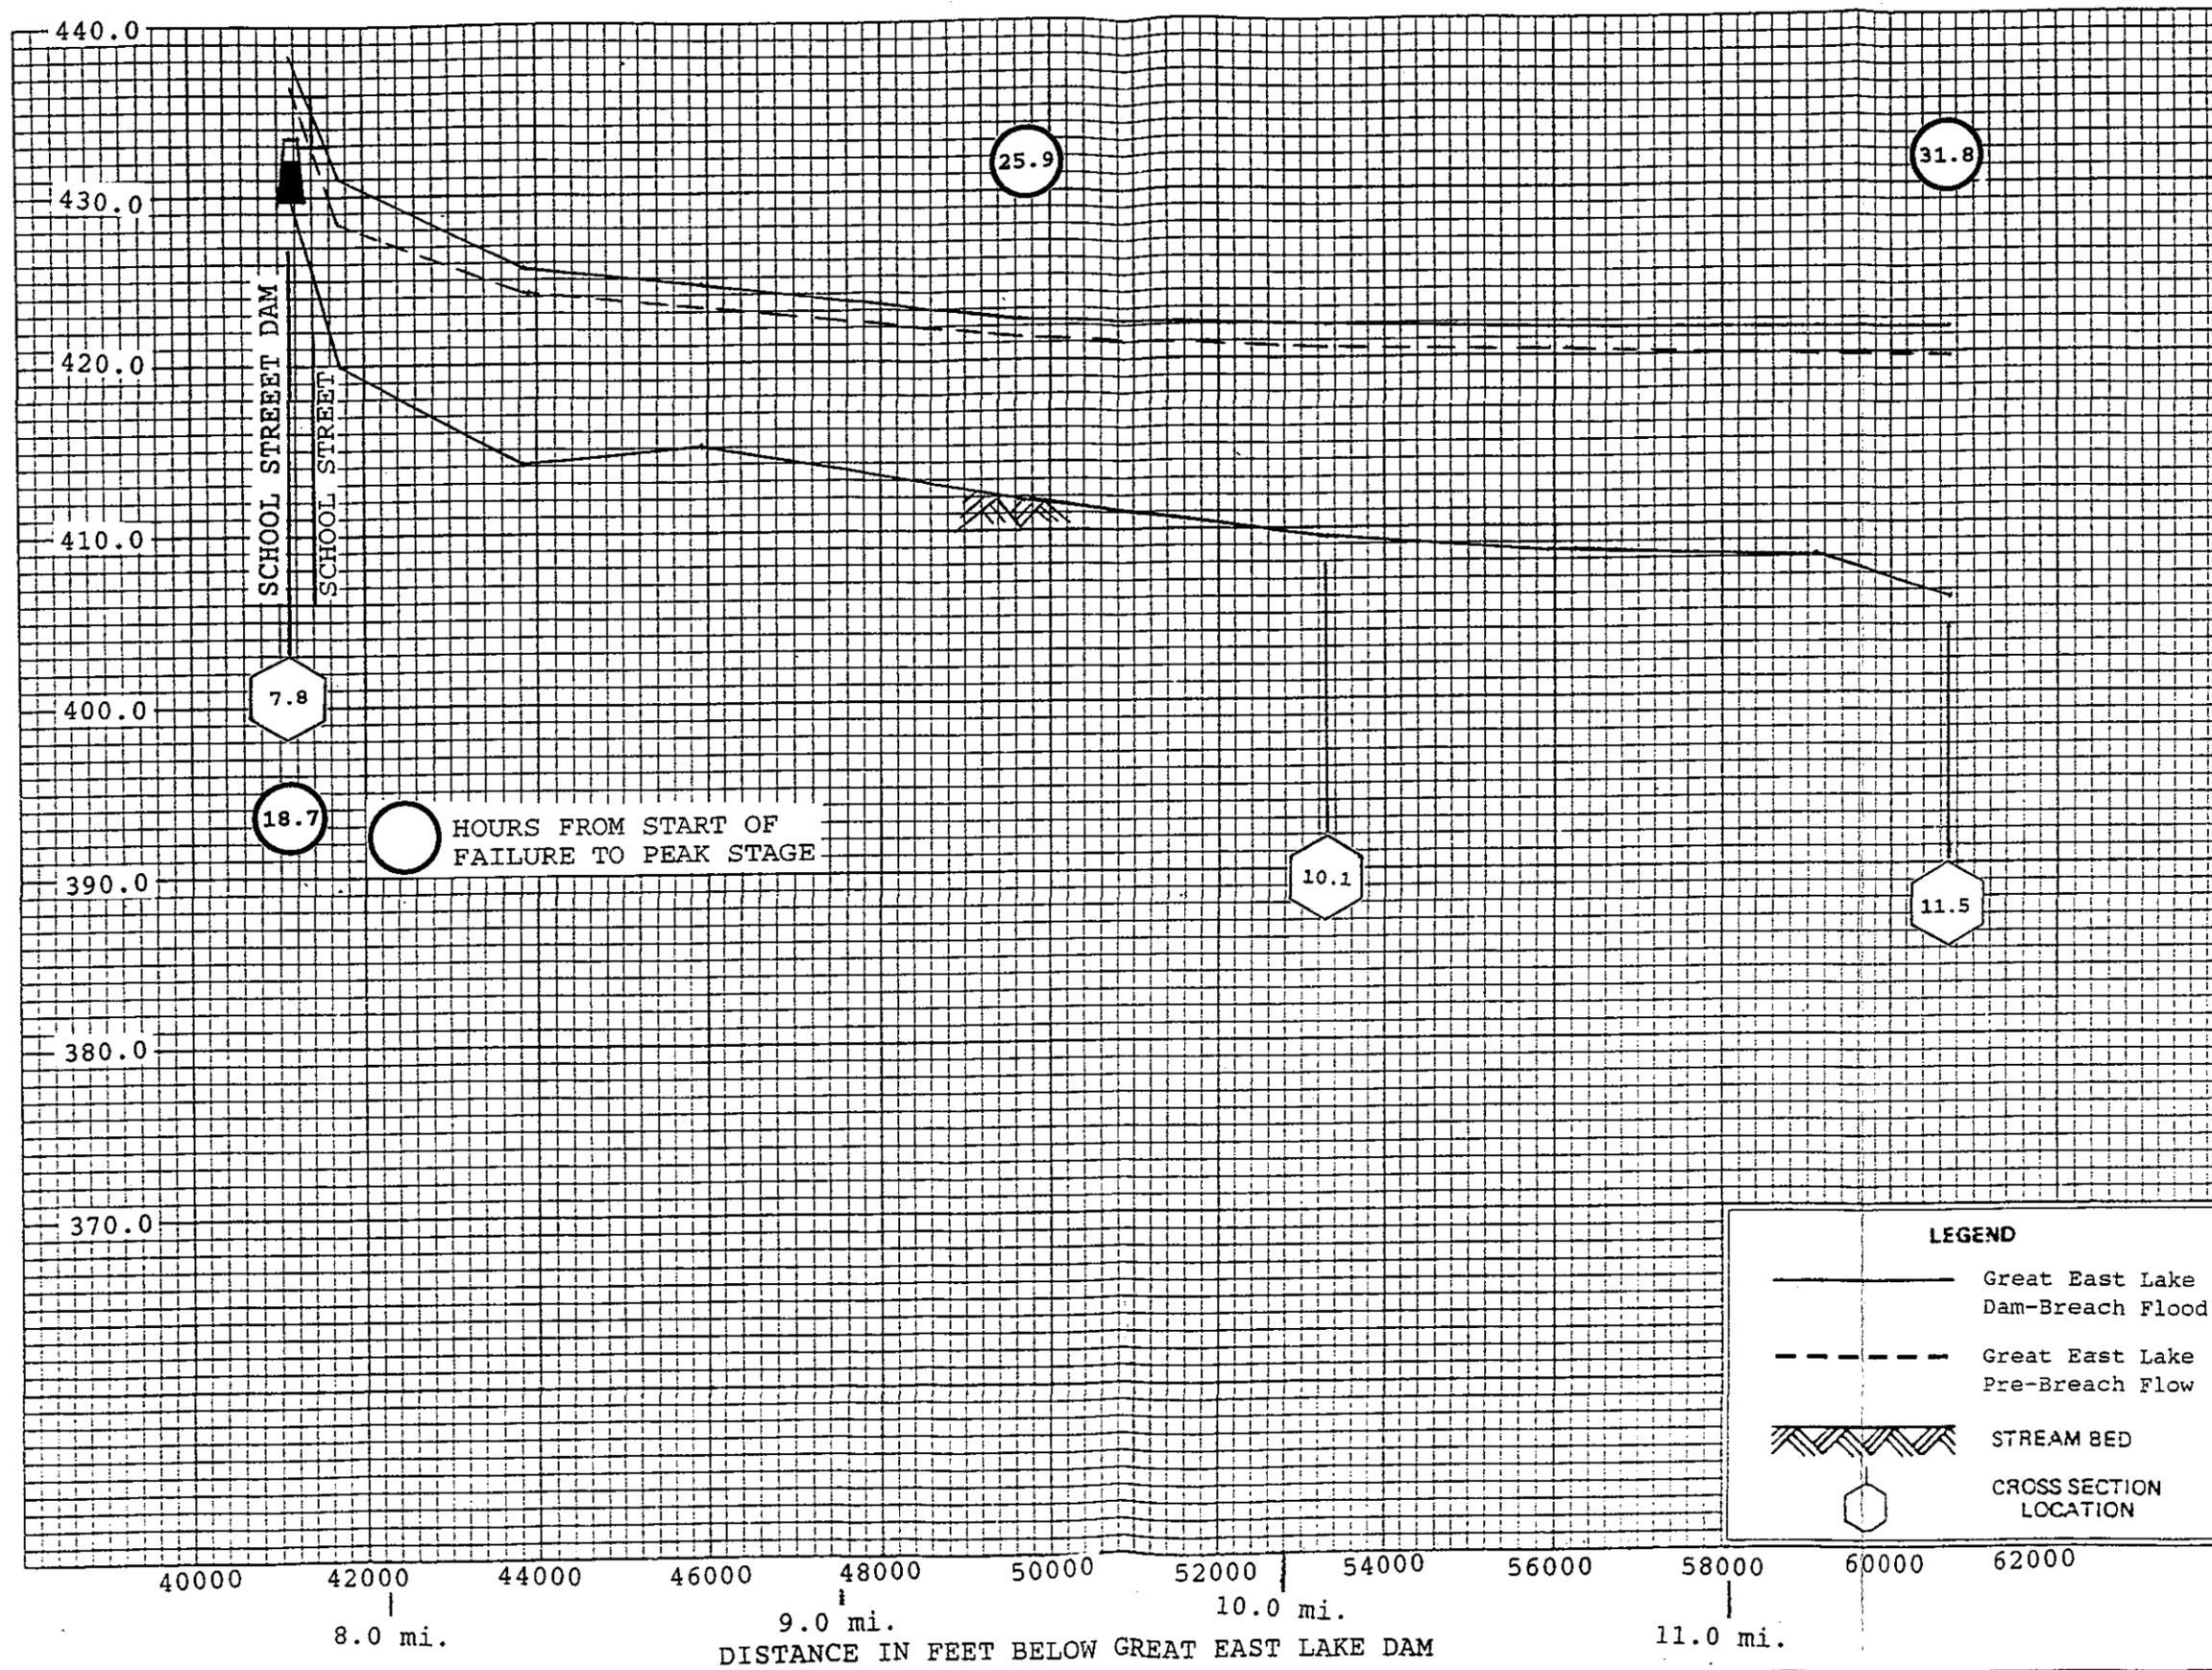
SALMON FALLS RIVER - PROFILE #3

FLOOD PROFILES

GREAT EAST LAKE DAM  
DAM-BREACH FLOOD ANALYSIS

Plates 5 - 9 show peak water surface profiles resulting from the pre-breach initial flow and failure flow. The peak dam-breach discharge computed by the DAMBRK computer program is about 6,700 cfs. This flow results in a stage increase of about 16.0 feet over the prebreach high flow just downstream of the dam. The peak breach discharge attenuates to about 3,600 cfs at river mile 1.65, and increases to 6,900 cfs at rivermile 16.4 due to high pre-breach flows. The breach flow would overtop Milton Three Ponds Dam by approximately 3.5 feet. At areas below this point, peak stages would only be about 1.0 feet above the assumed pre-breach flows.

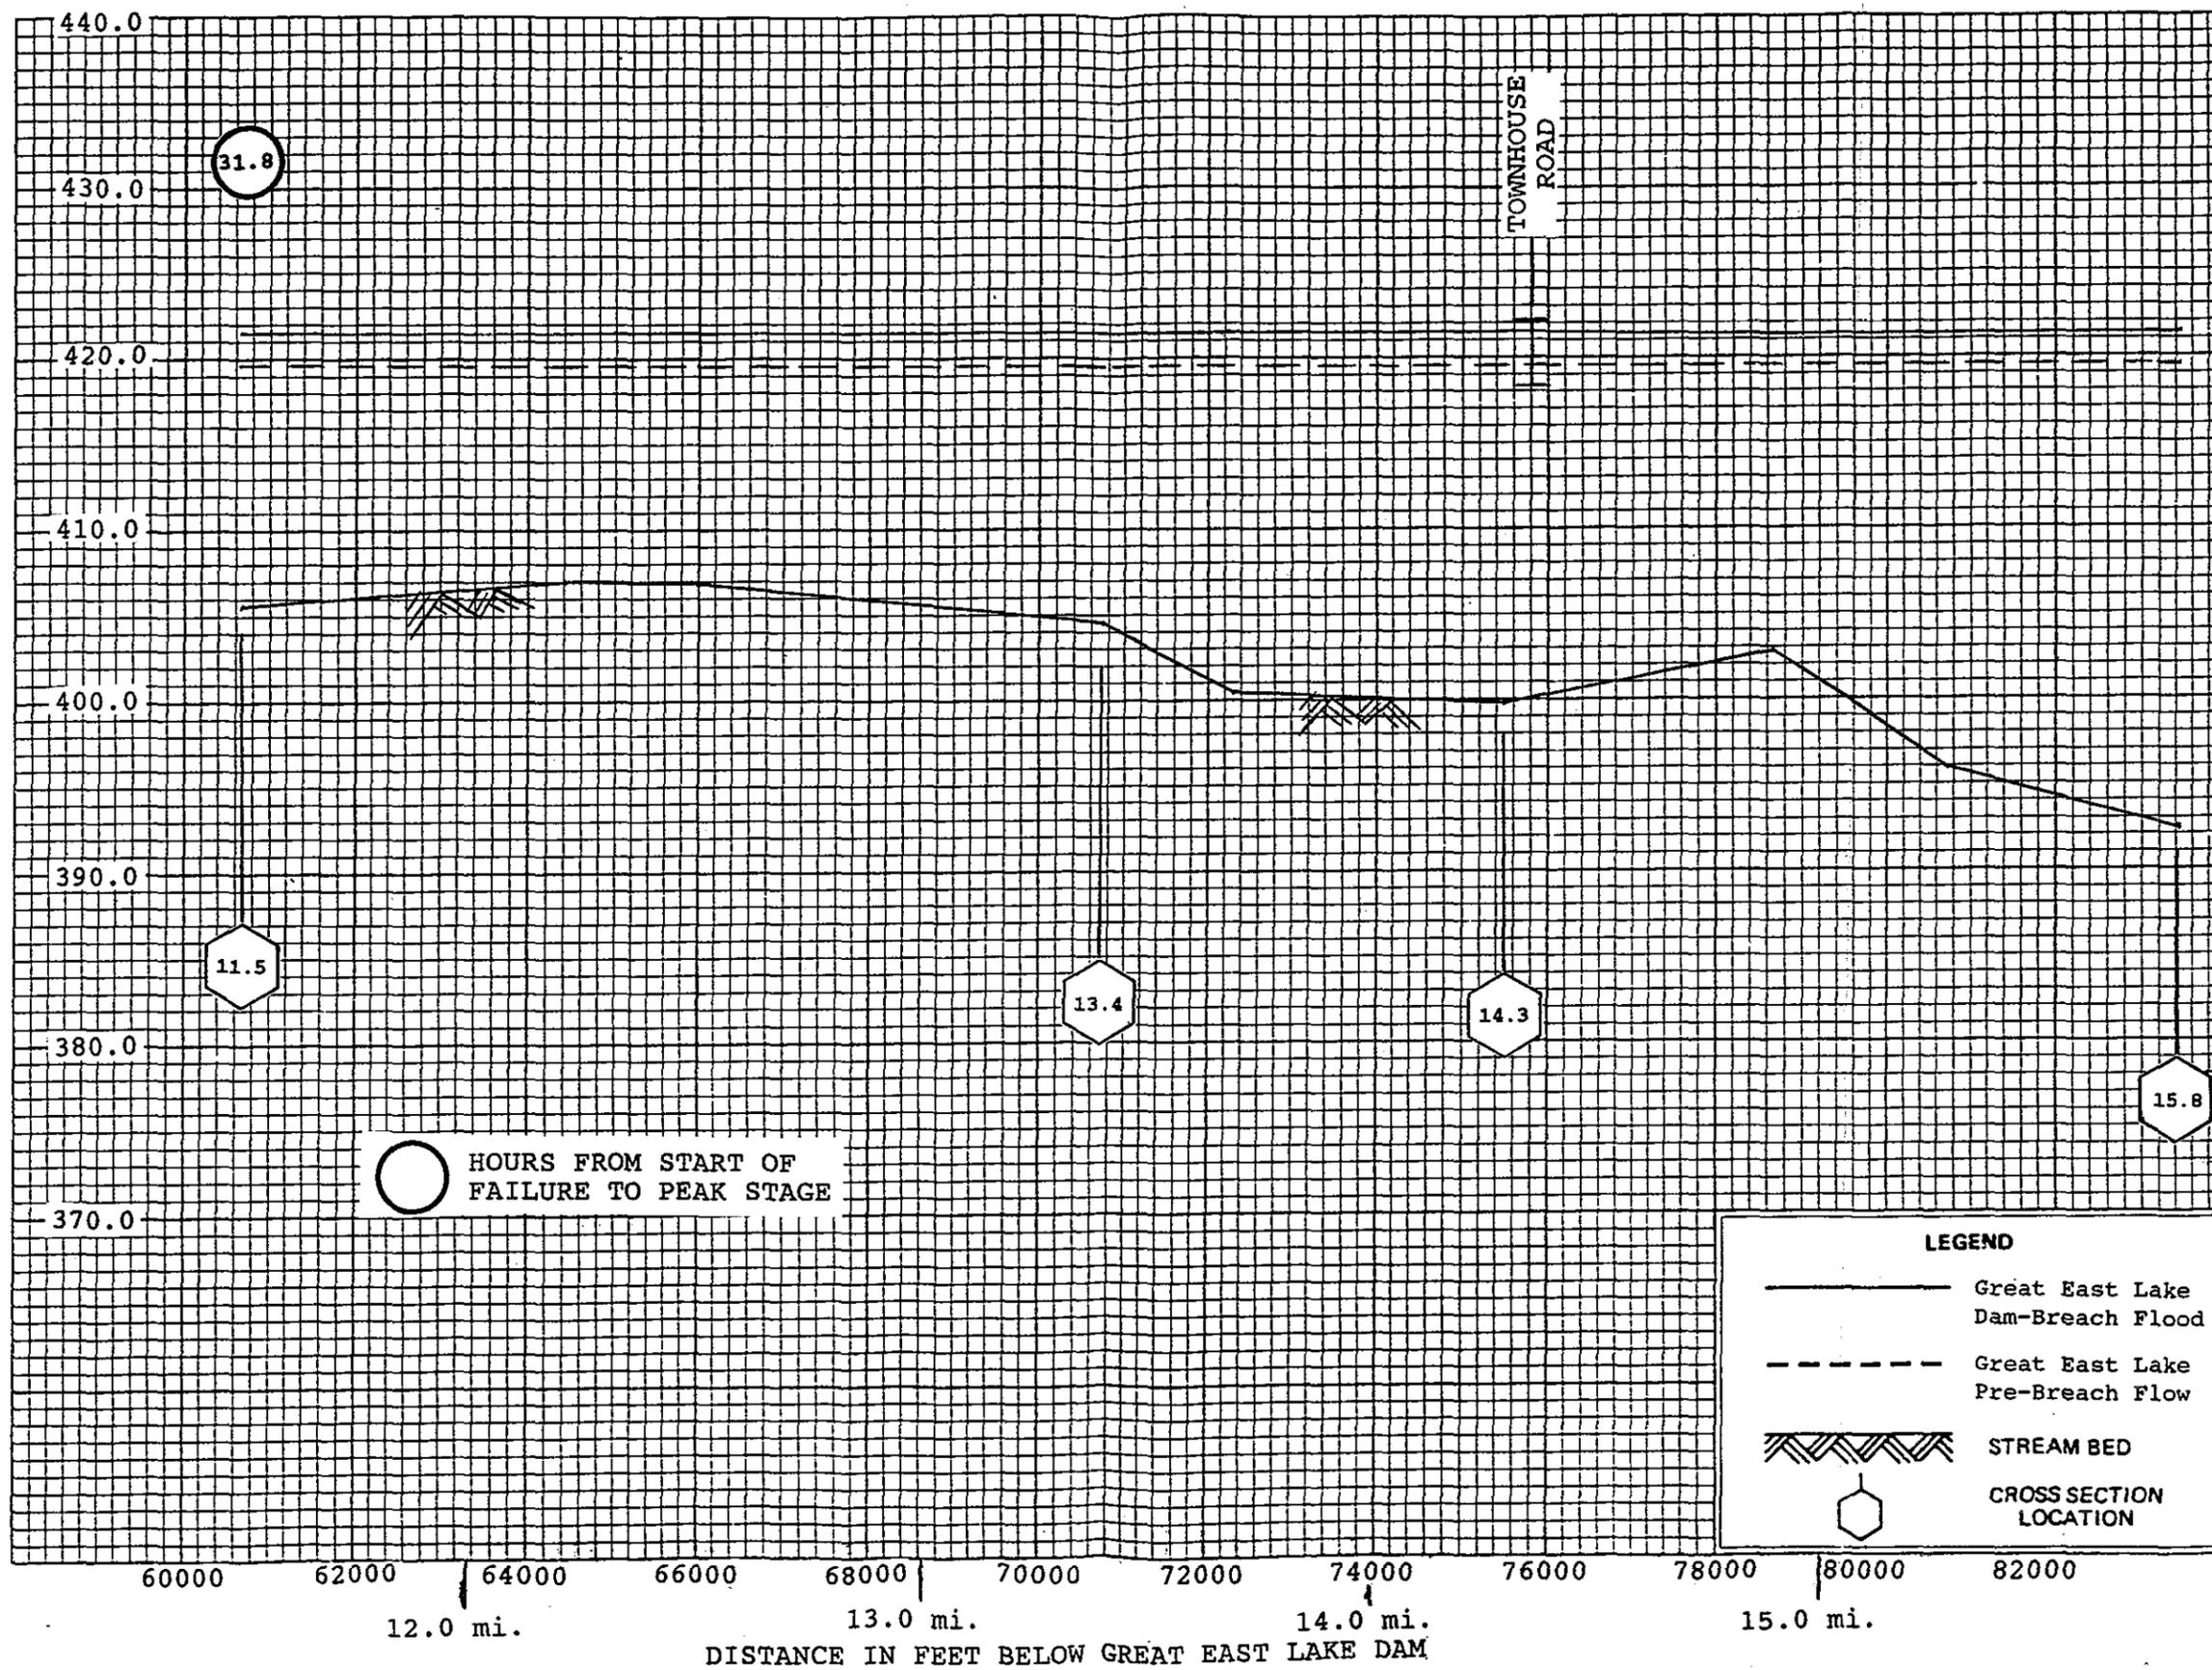
SALMON FALLS RIVER - PROFILE #4

FLOOD PROFILES

GREAT EAST LAKE DAM  
DAM-BREACH FLOOD ANALYSIS

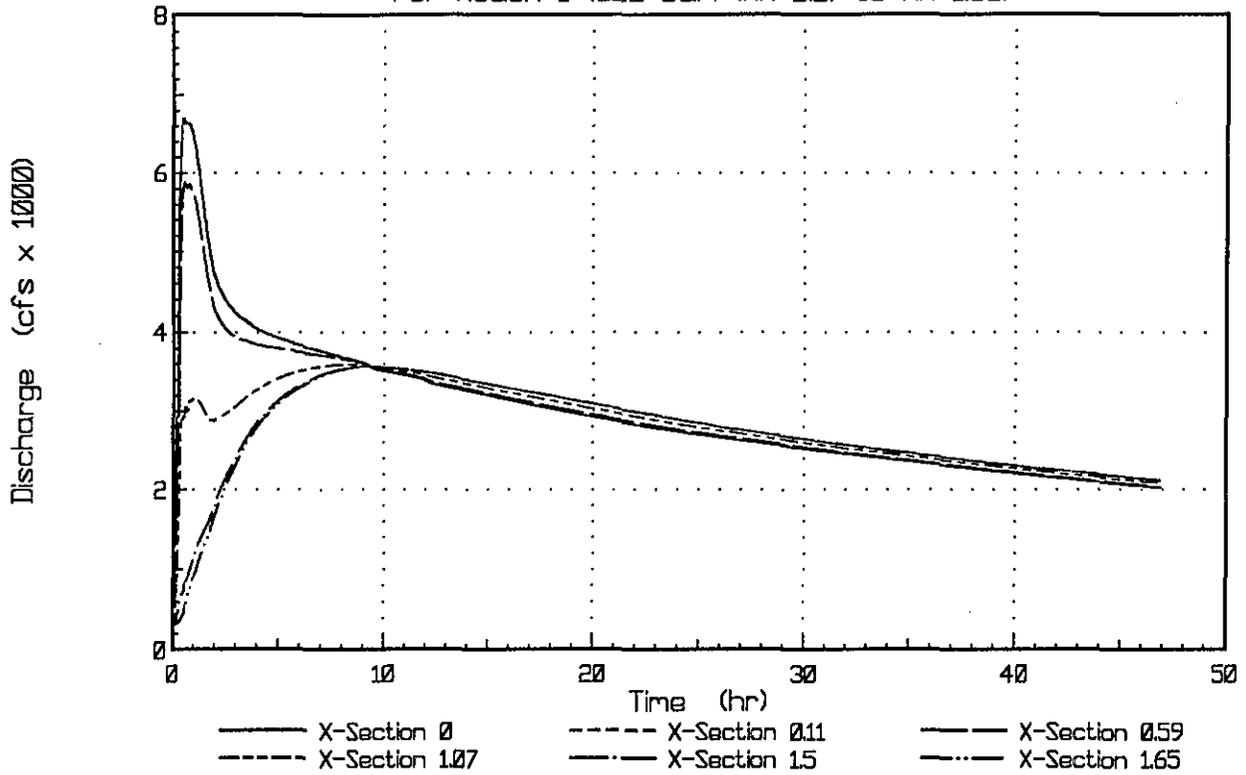
### Combined Discharge Hydrographs For Reach 1 (GEL Dam (RM 00) to RM 1.65)

A rapid failure (0.5 hours) of the 16.2 feet high dam results in a fast rise to a peak discharge of about 6,700 cfs. However, as time progresses the major portion of the breach hydrograph consists of water discharging from the large storage capacity of the lake. The initial fast rising breach hydrograph is attenuated within the surcharge storage of the downstream Horn Pond Dam impoundment. Analysis of the breach hydrograph and the hydrograph at mile 1.65 shows that about 5,800 acre-feet of storage is utilized between the pre-breach stage of 12 feet and the peak stage of 16 feet (spillway crest at 10.4 feet stage). This reduces the hydrograph peak discharge and results in increasing the time to peak stage as the flood wave passes through Horn Pond. Discharge and stage hydrographs throughout the reach are shown in Plates 10 and 11.

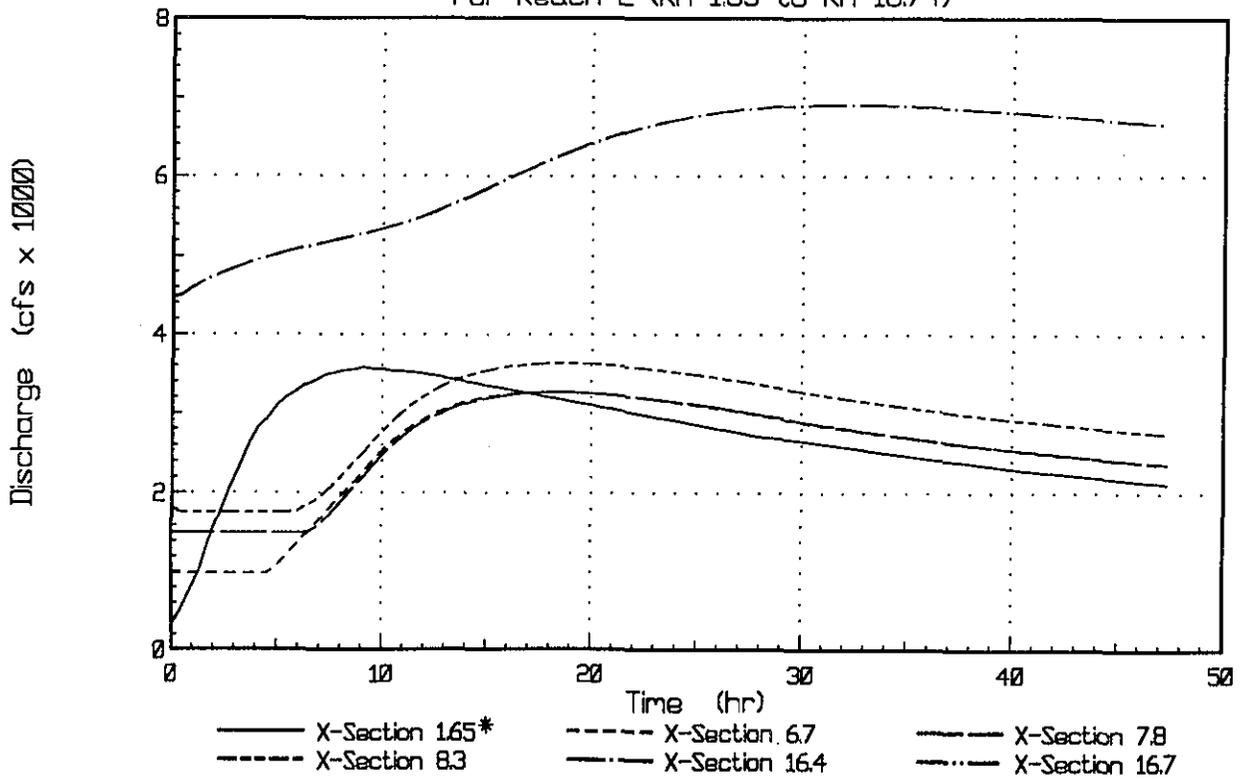
### Combined Discharge Hydrographs For Reach 2 (RM 1.65 to RM 16.74)

Note: Start of Failure at 0.5 Hours.

\* Outflow hydrograph from Horn Pond Dam.

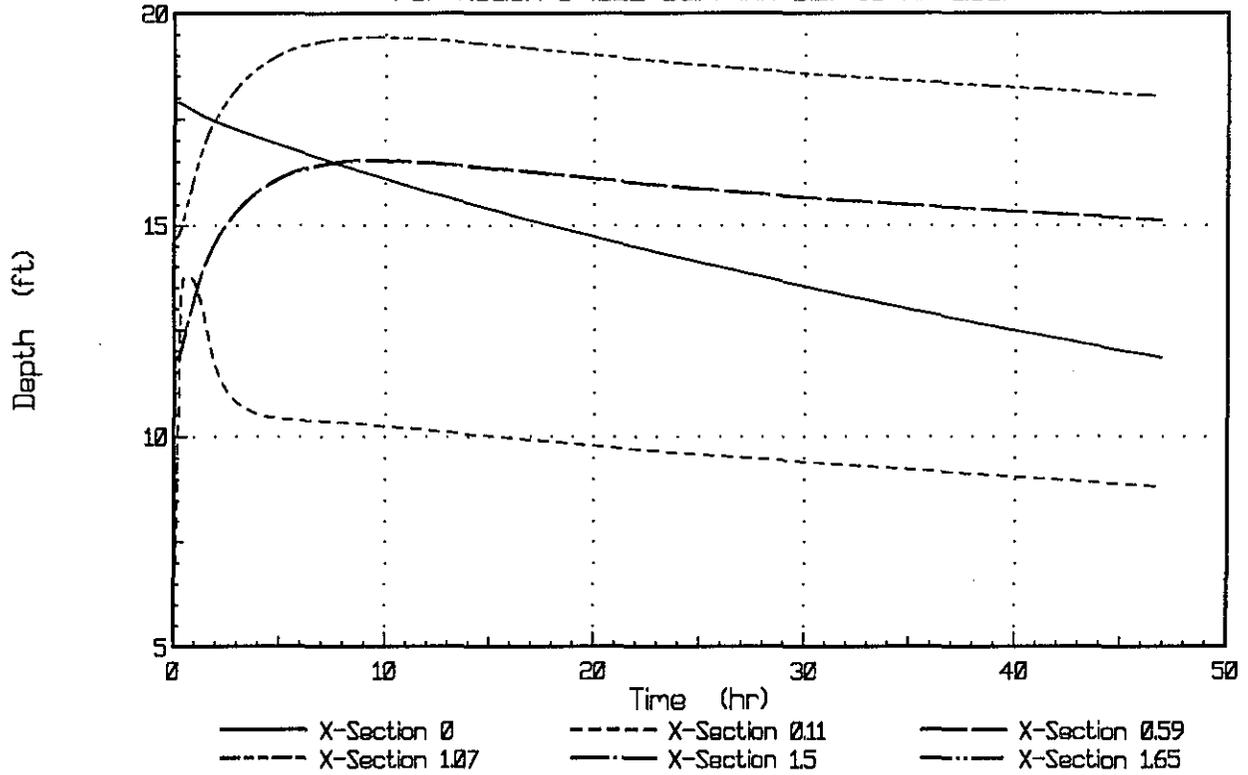
### Combined Flow Depth Hydrographs For Reach 1 (GEL Dam (RM 0.0) to RM 1.65)

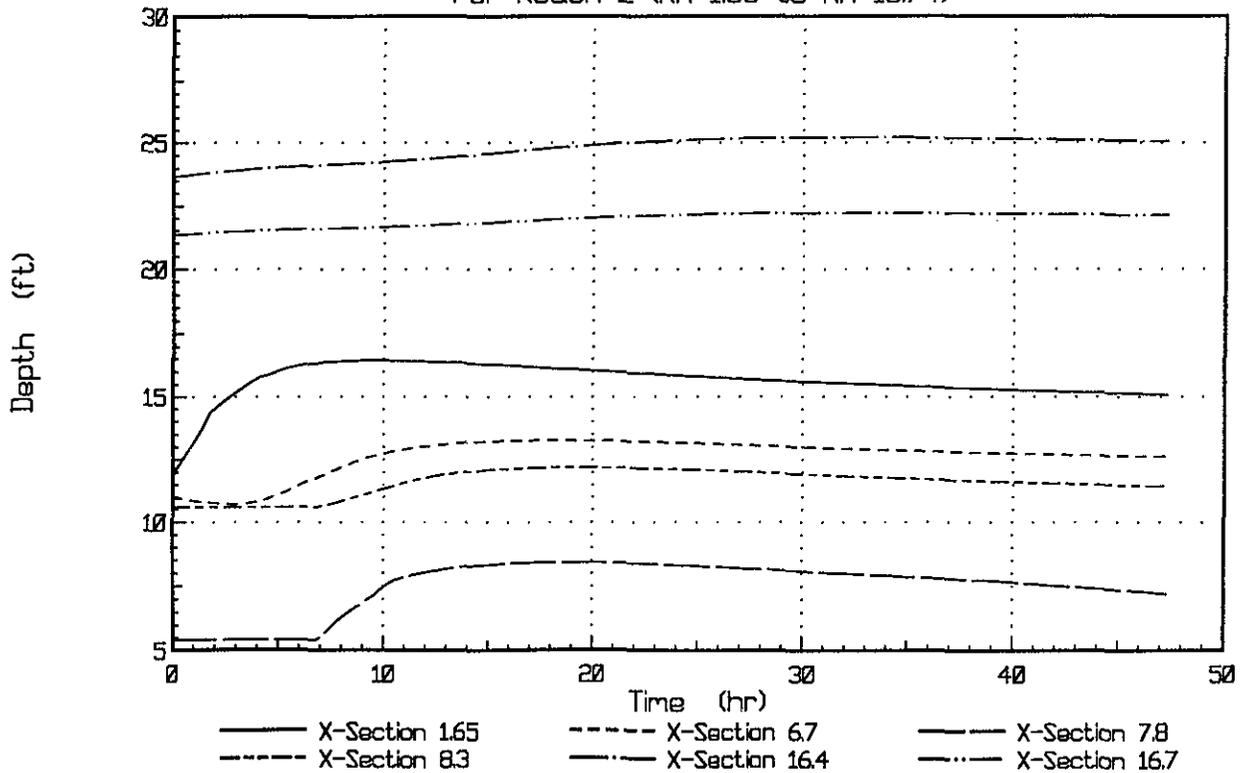
### Combined Flow Depth Hydrographs For Reach 2 (RM 1.65 to RM 16.74)

Note: Start of Dam Failure at 0.5 Hours.

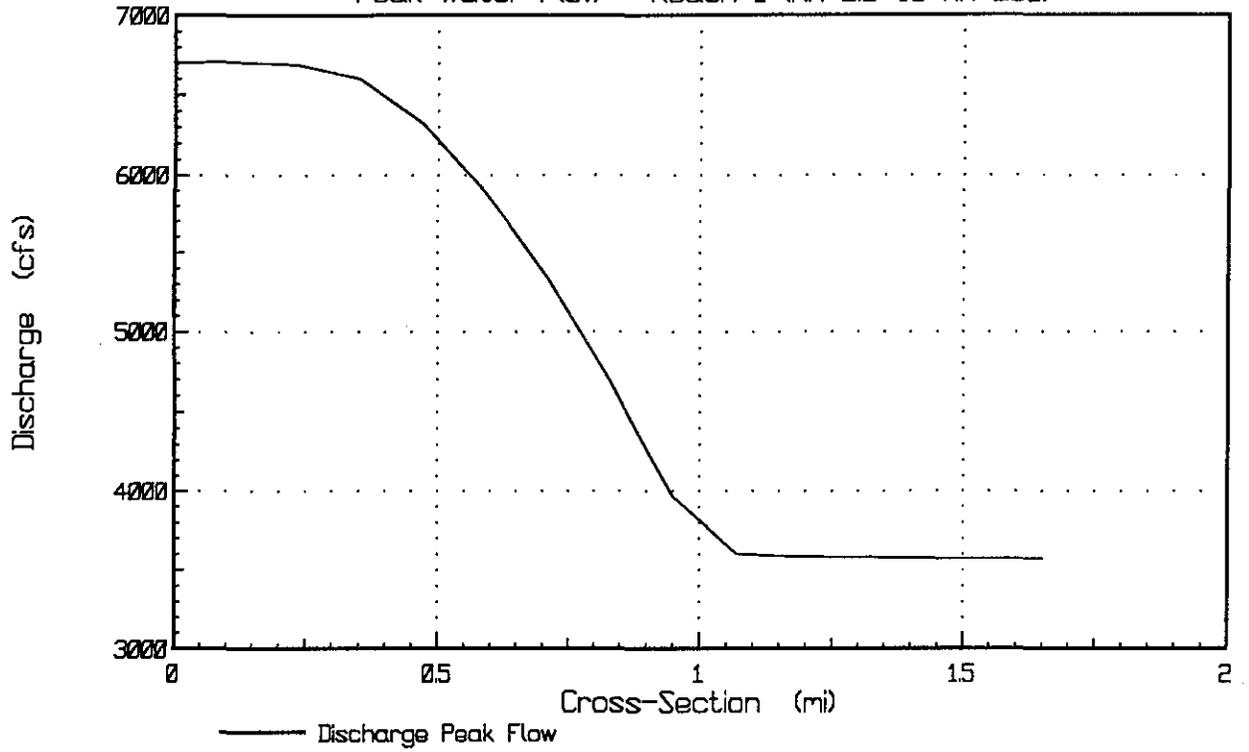
Flood Discharge Summary  
Peak Water Flow - Reach 1 (RM 0.0 to RM 1.65)

The failure at Great East Lake Dam resulted in a peak breach discharge of approximately 6,700 cfs. The assumed water surface was at 1.7 feet above the top of the dam, elevation 577.1 feet NGVD when failure began, and the breach was modeled to develop fully within 0.5 hours. Plates 5 - 9 show the pre-breach and dam-breach flood profiles for the study reach; Plates 10 and 11 show the breach discharge and stage hydrographs for selected cross sections throughout the reach. Plate 12 shows how the breach flood peak discharge varies with distance downstream.

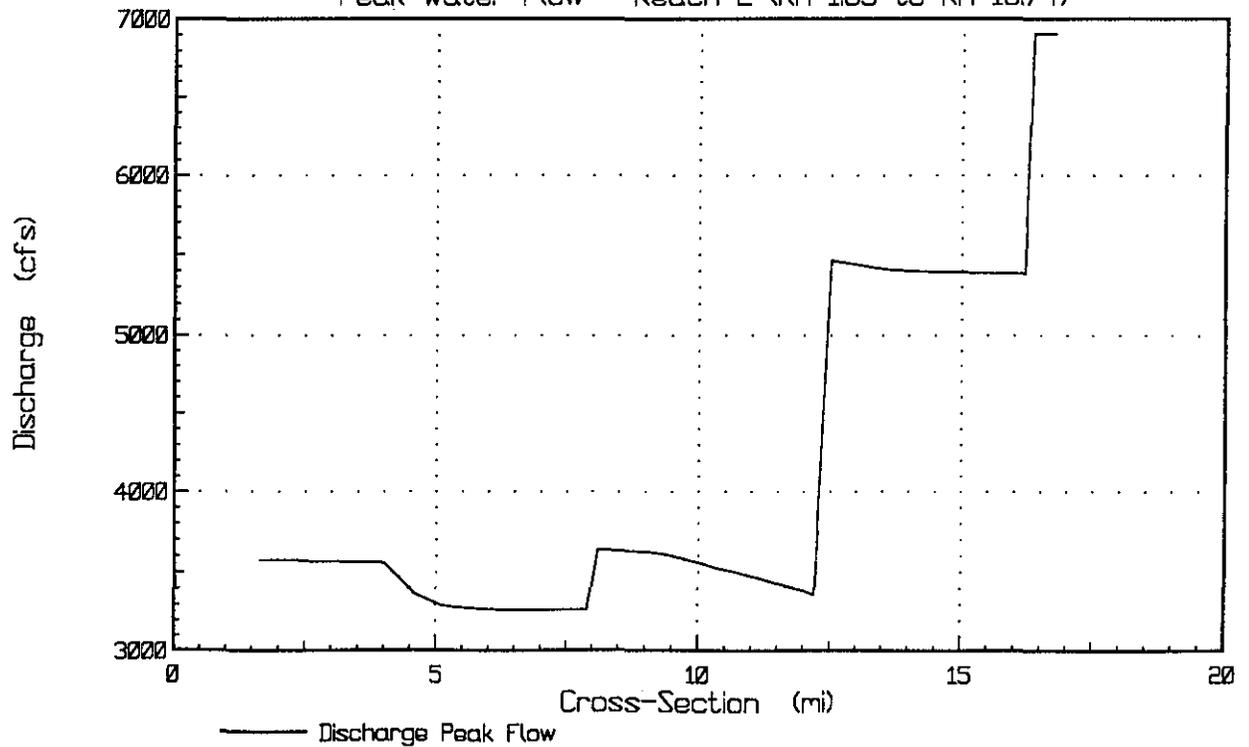
Flood Discharge Summary  
Peak Water Flow - Reach 2 (RM 1.65 to RM 16.74)
